Design and Construction of Creekside Town Center Bridges

Peter A. Giessel, P.E.
Reid Middleton, Inc.

Creekside Town Center Bridges

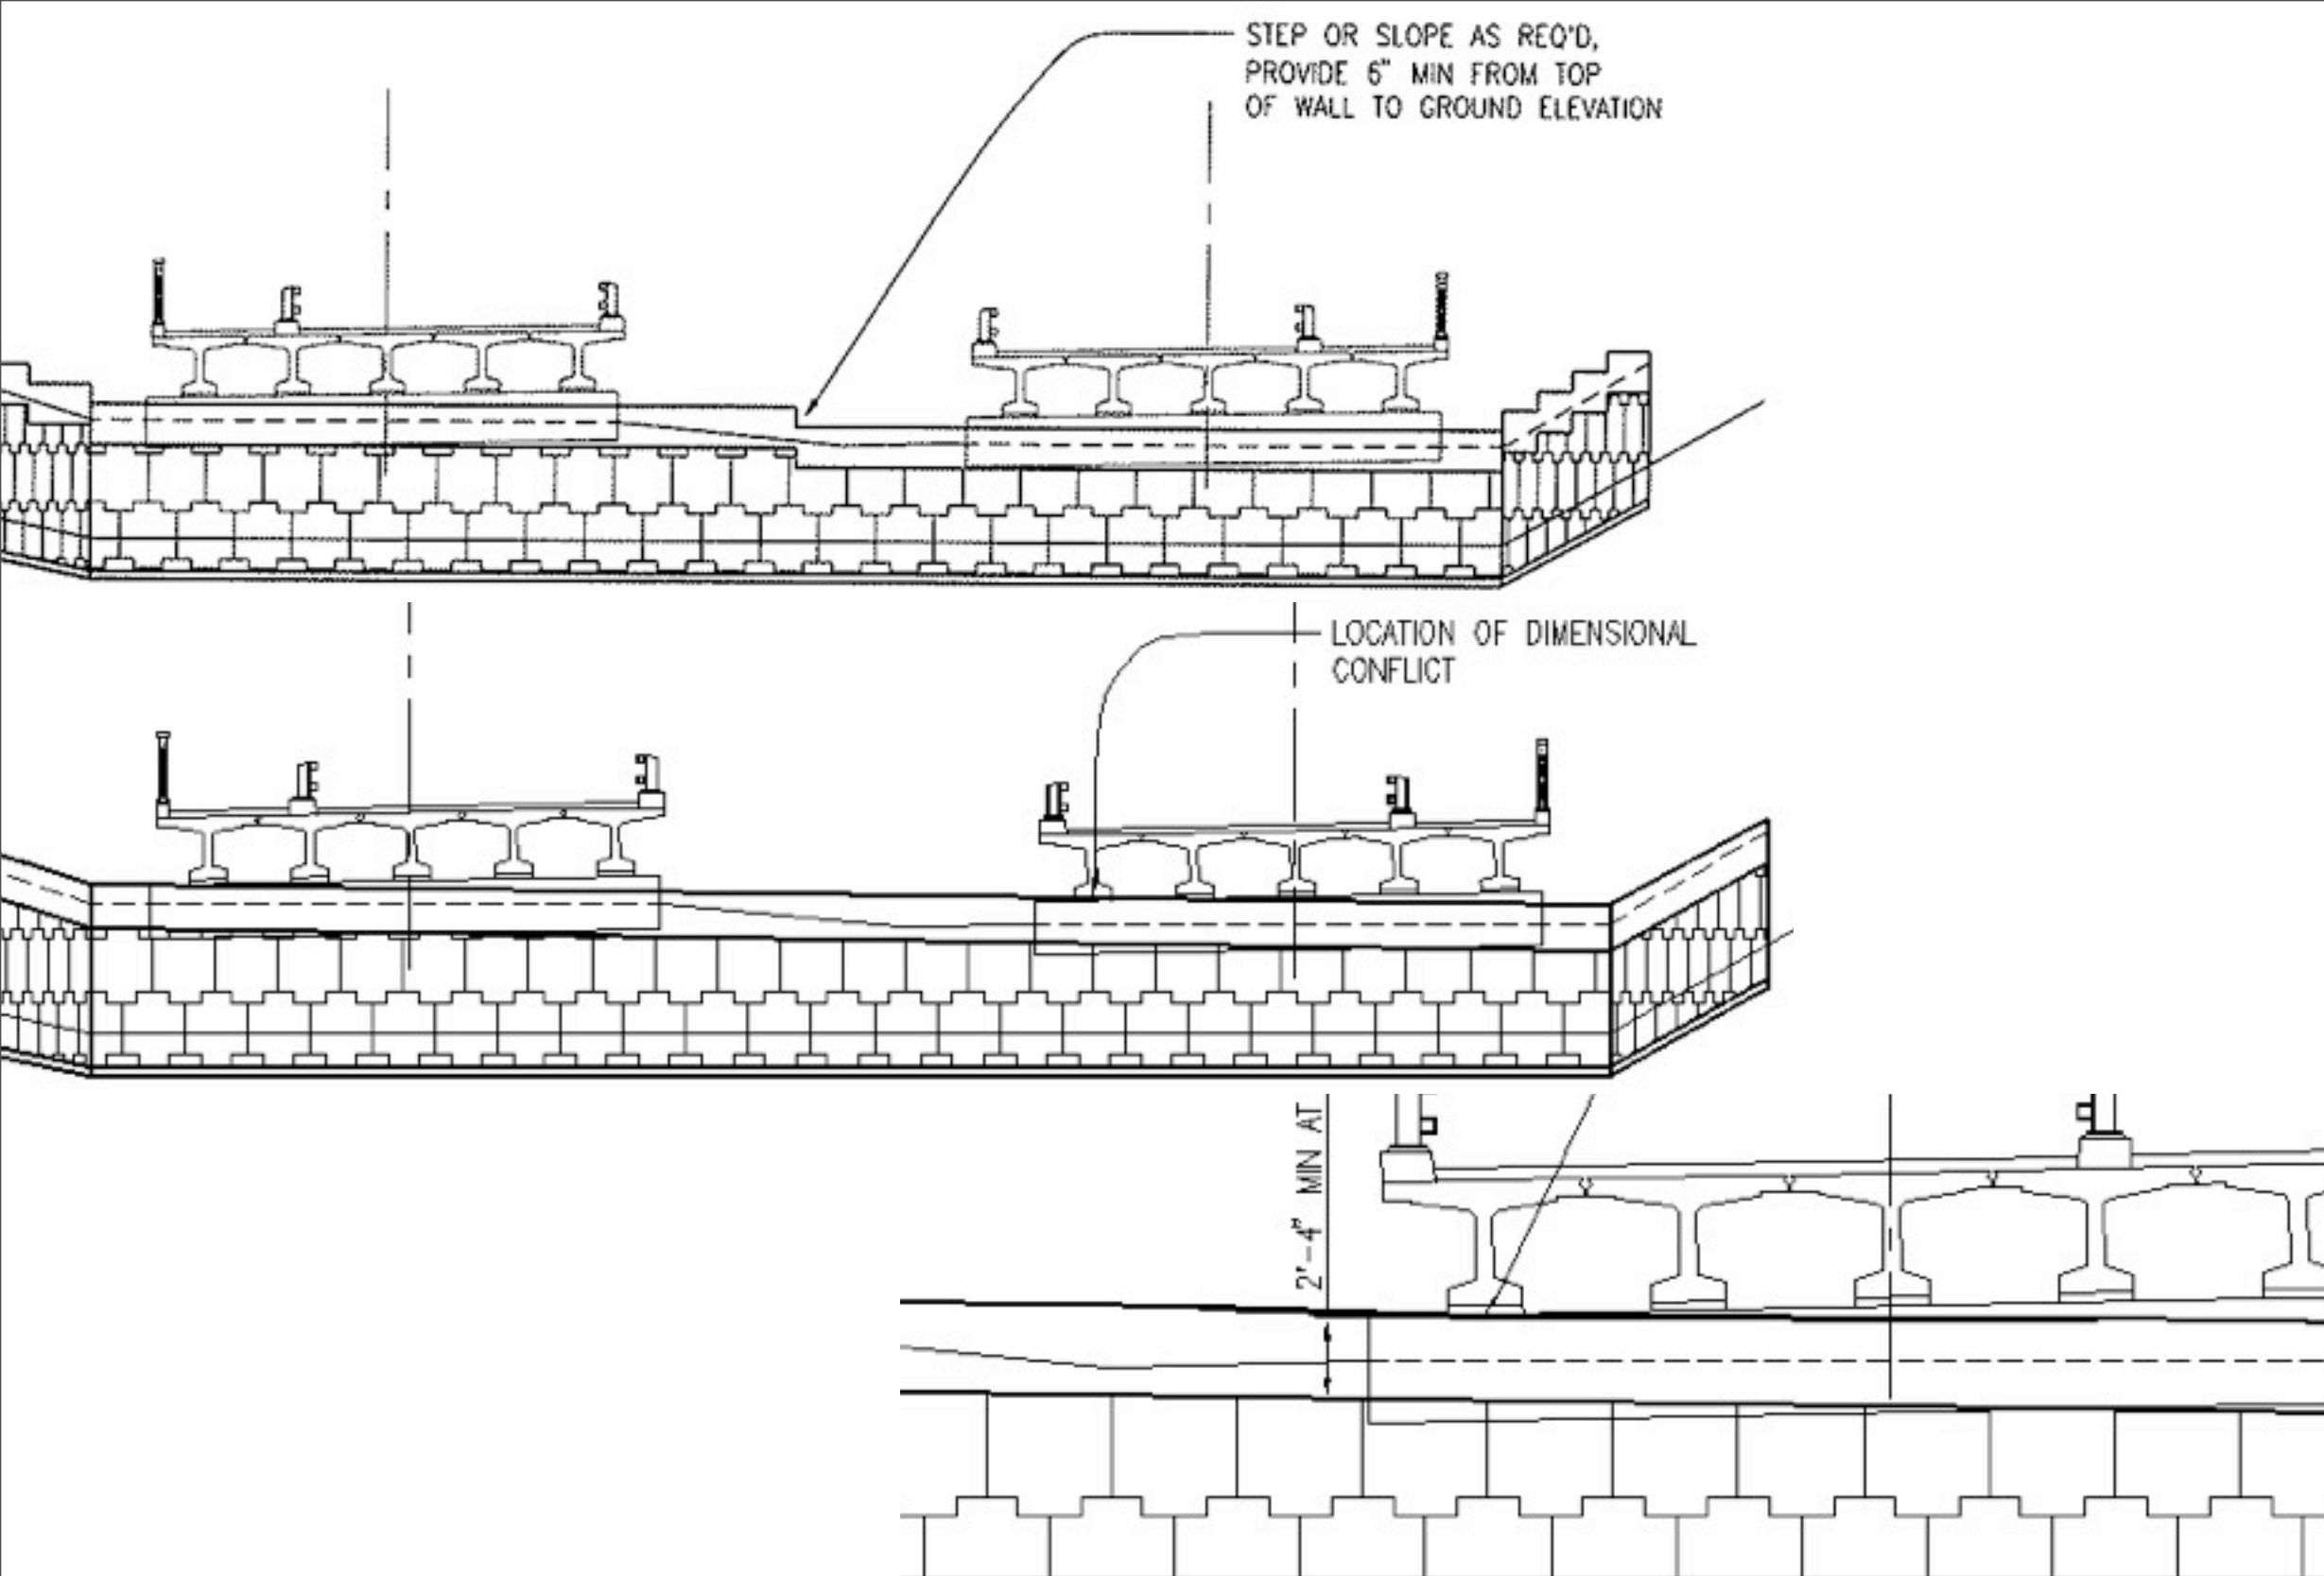
Coping Interference

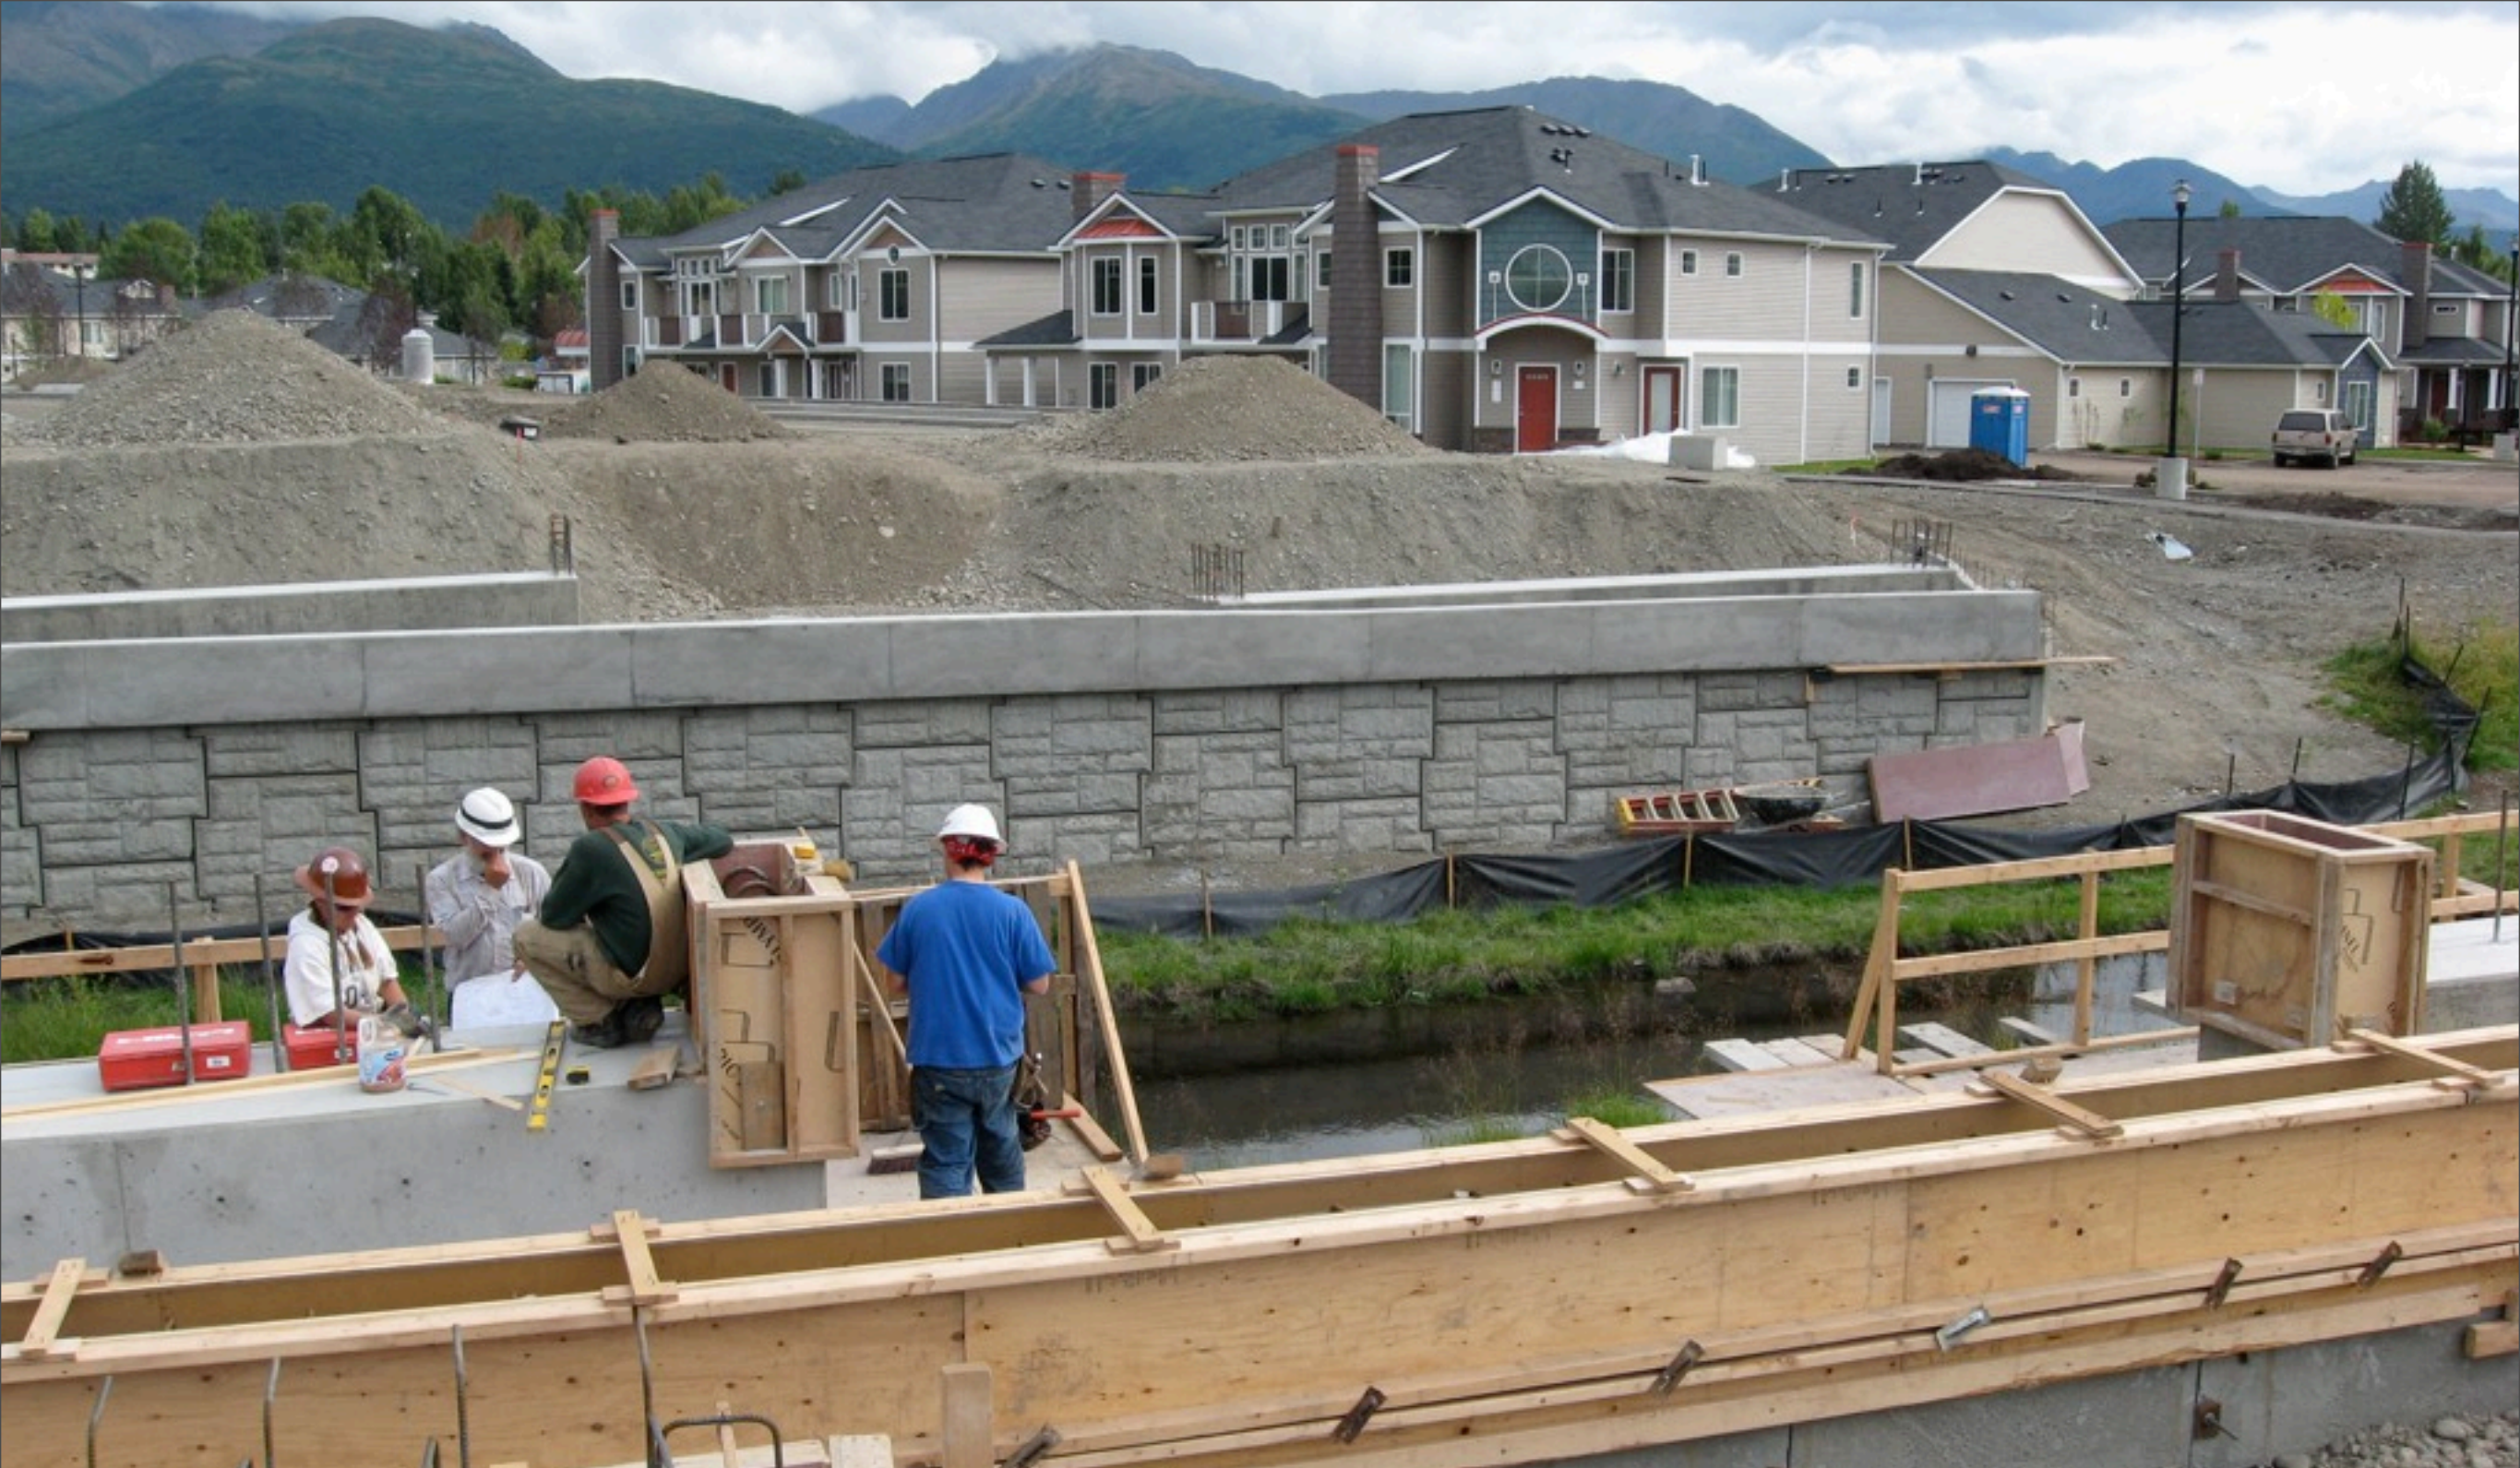
Dip in Coping

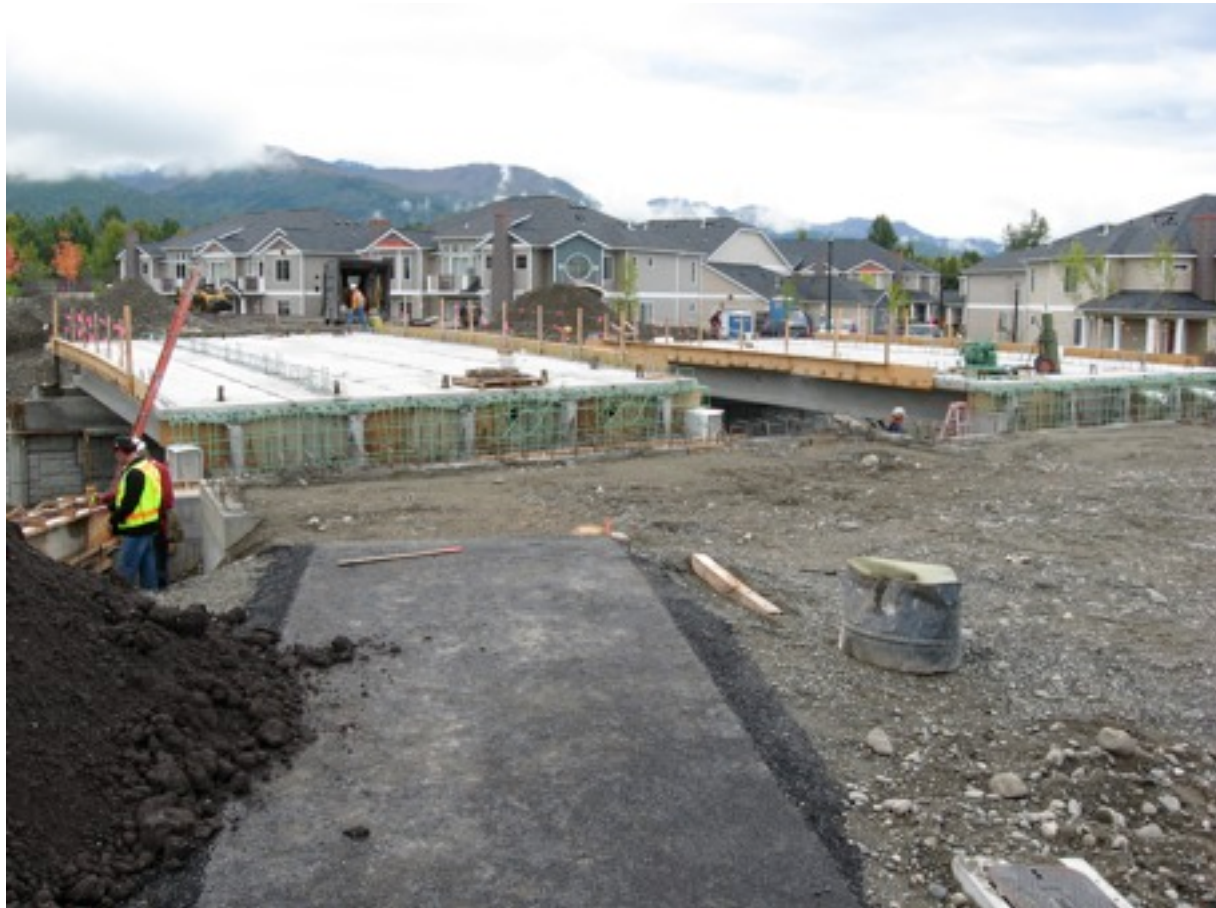
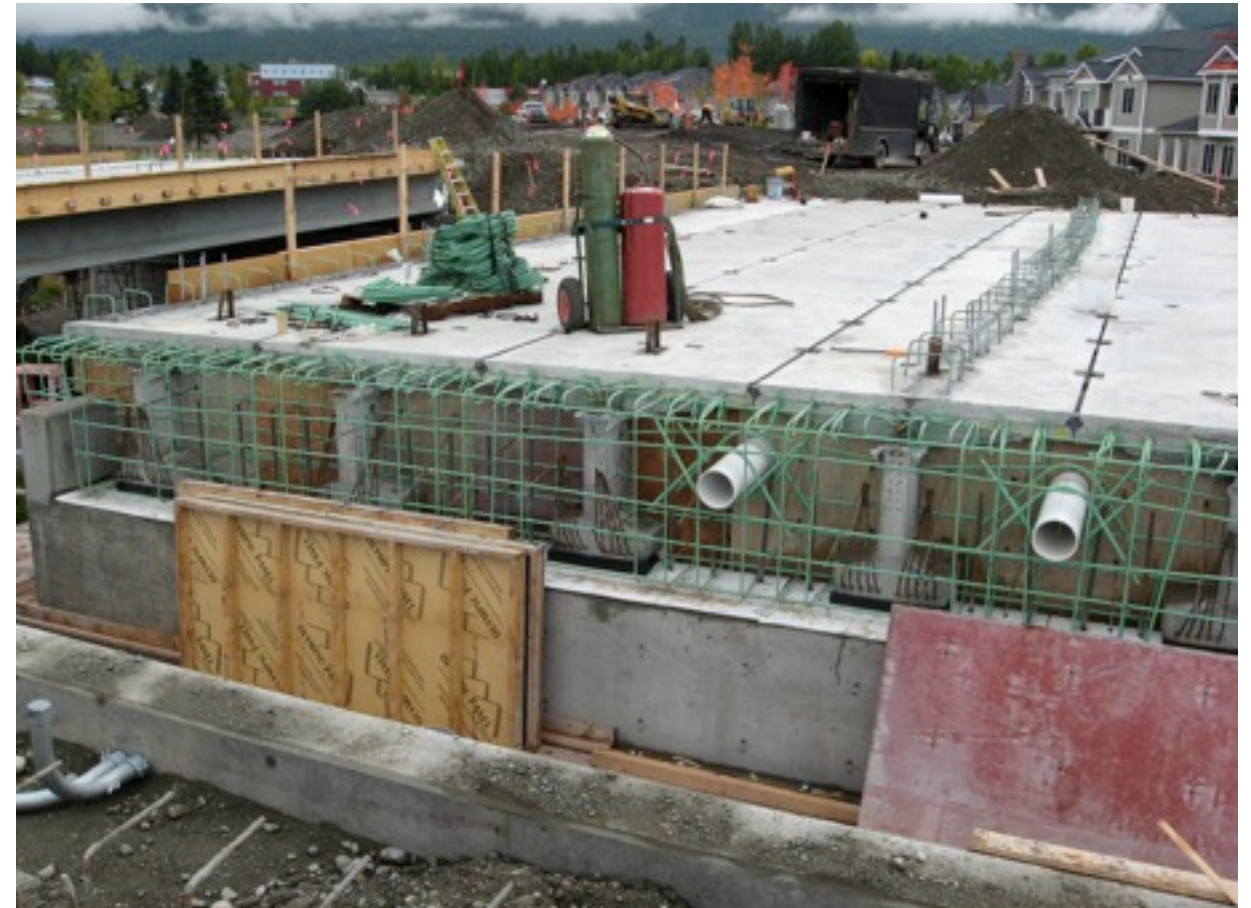
September 8, 2008 — Girders set
Final Girder Cast, August 5, 2008 less than 5 weeks prior

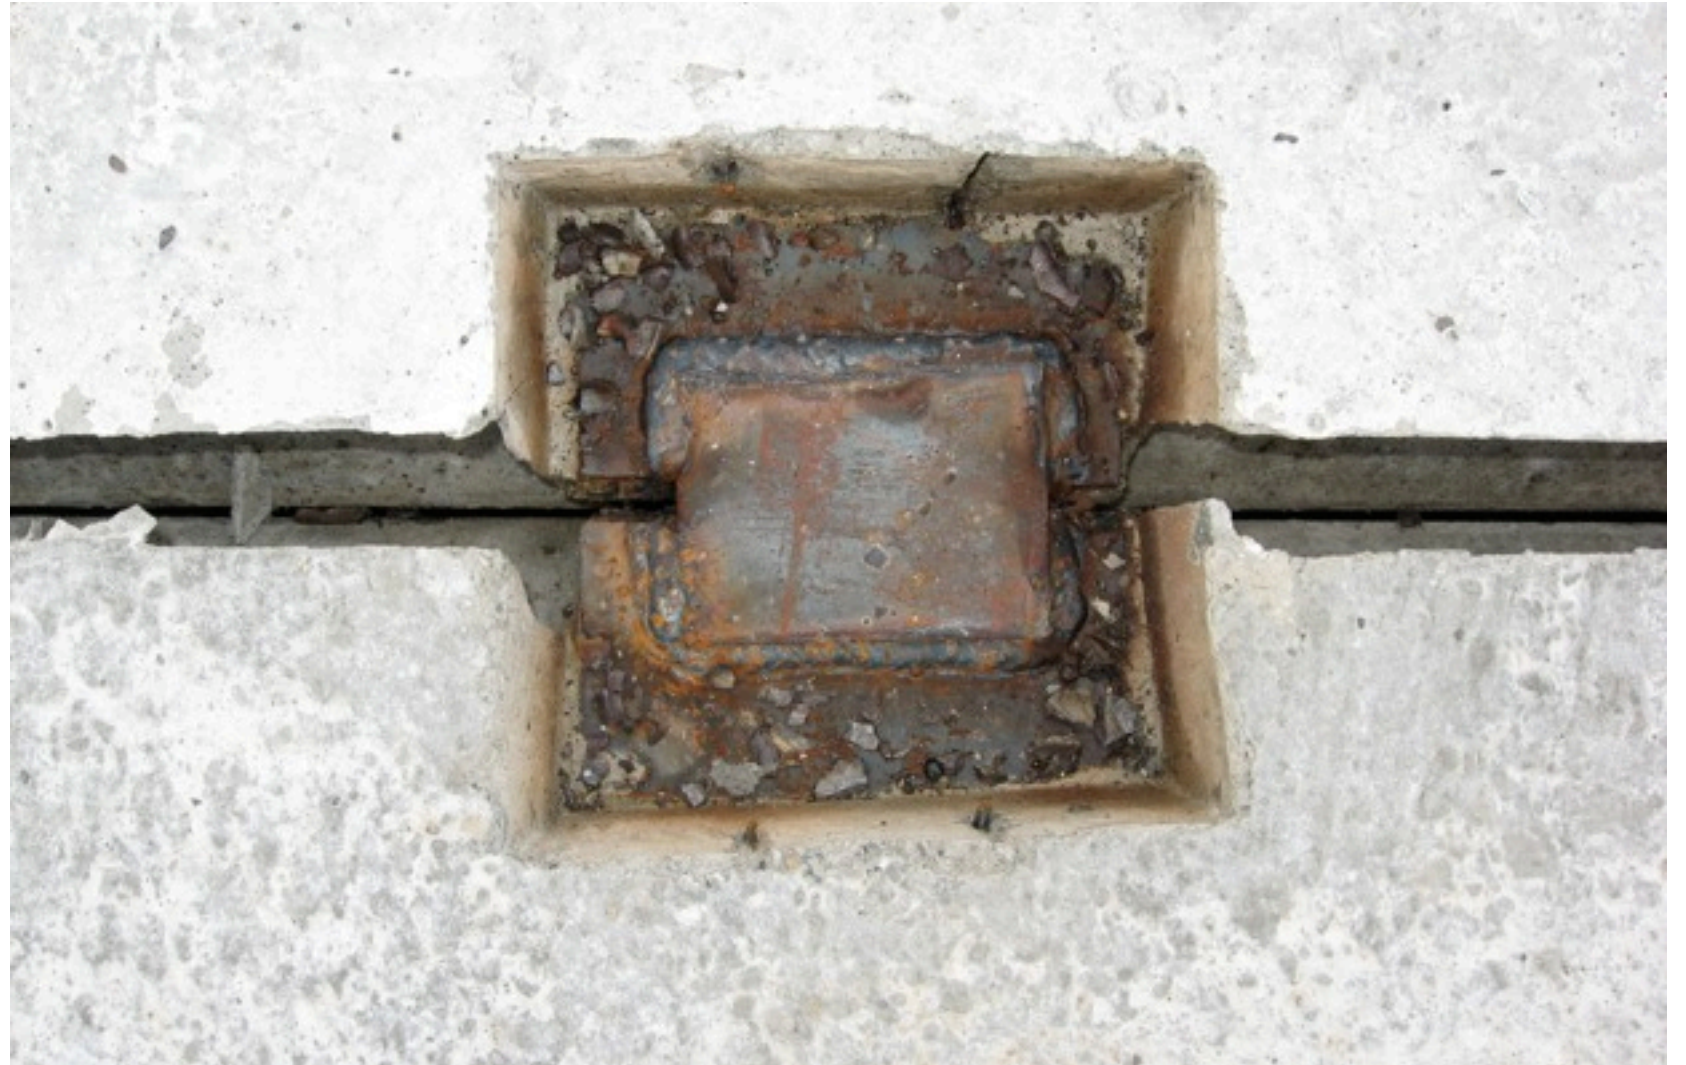
Shear Tab Detail — Welded shear tab and shear key to be grouted
September 8, 2008

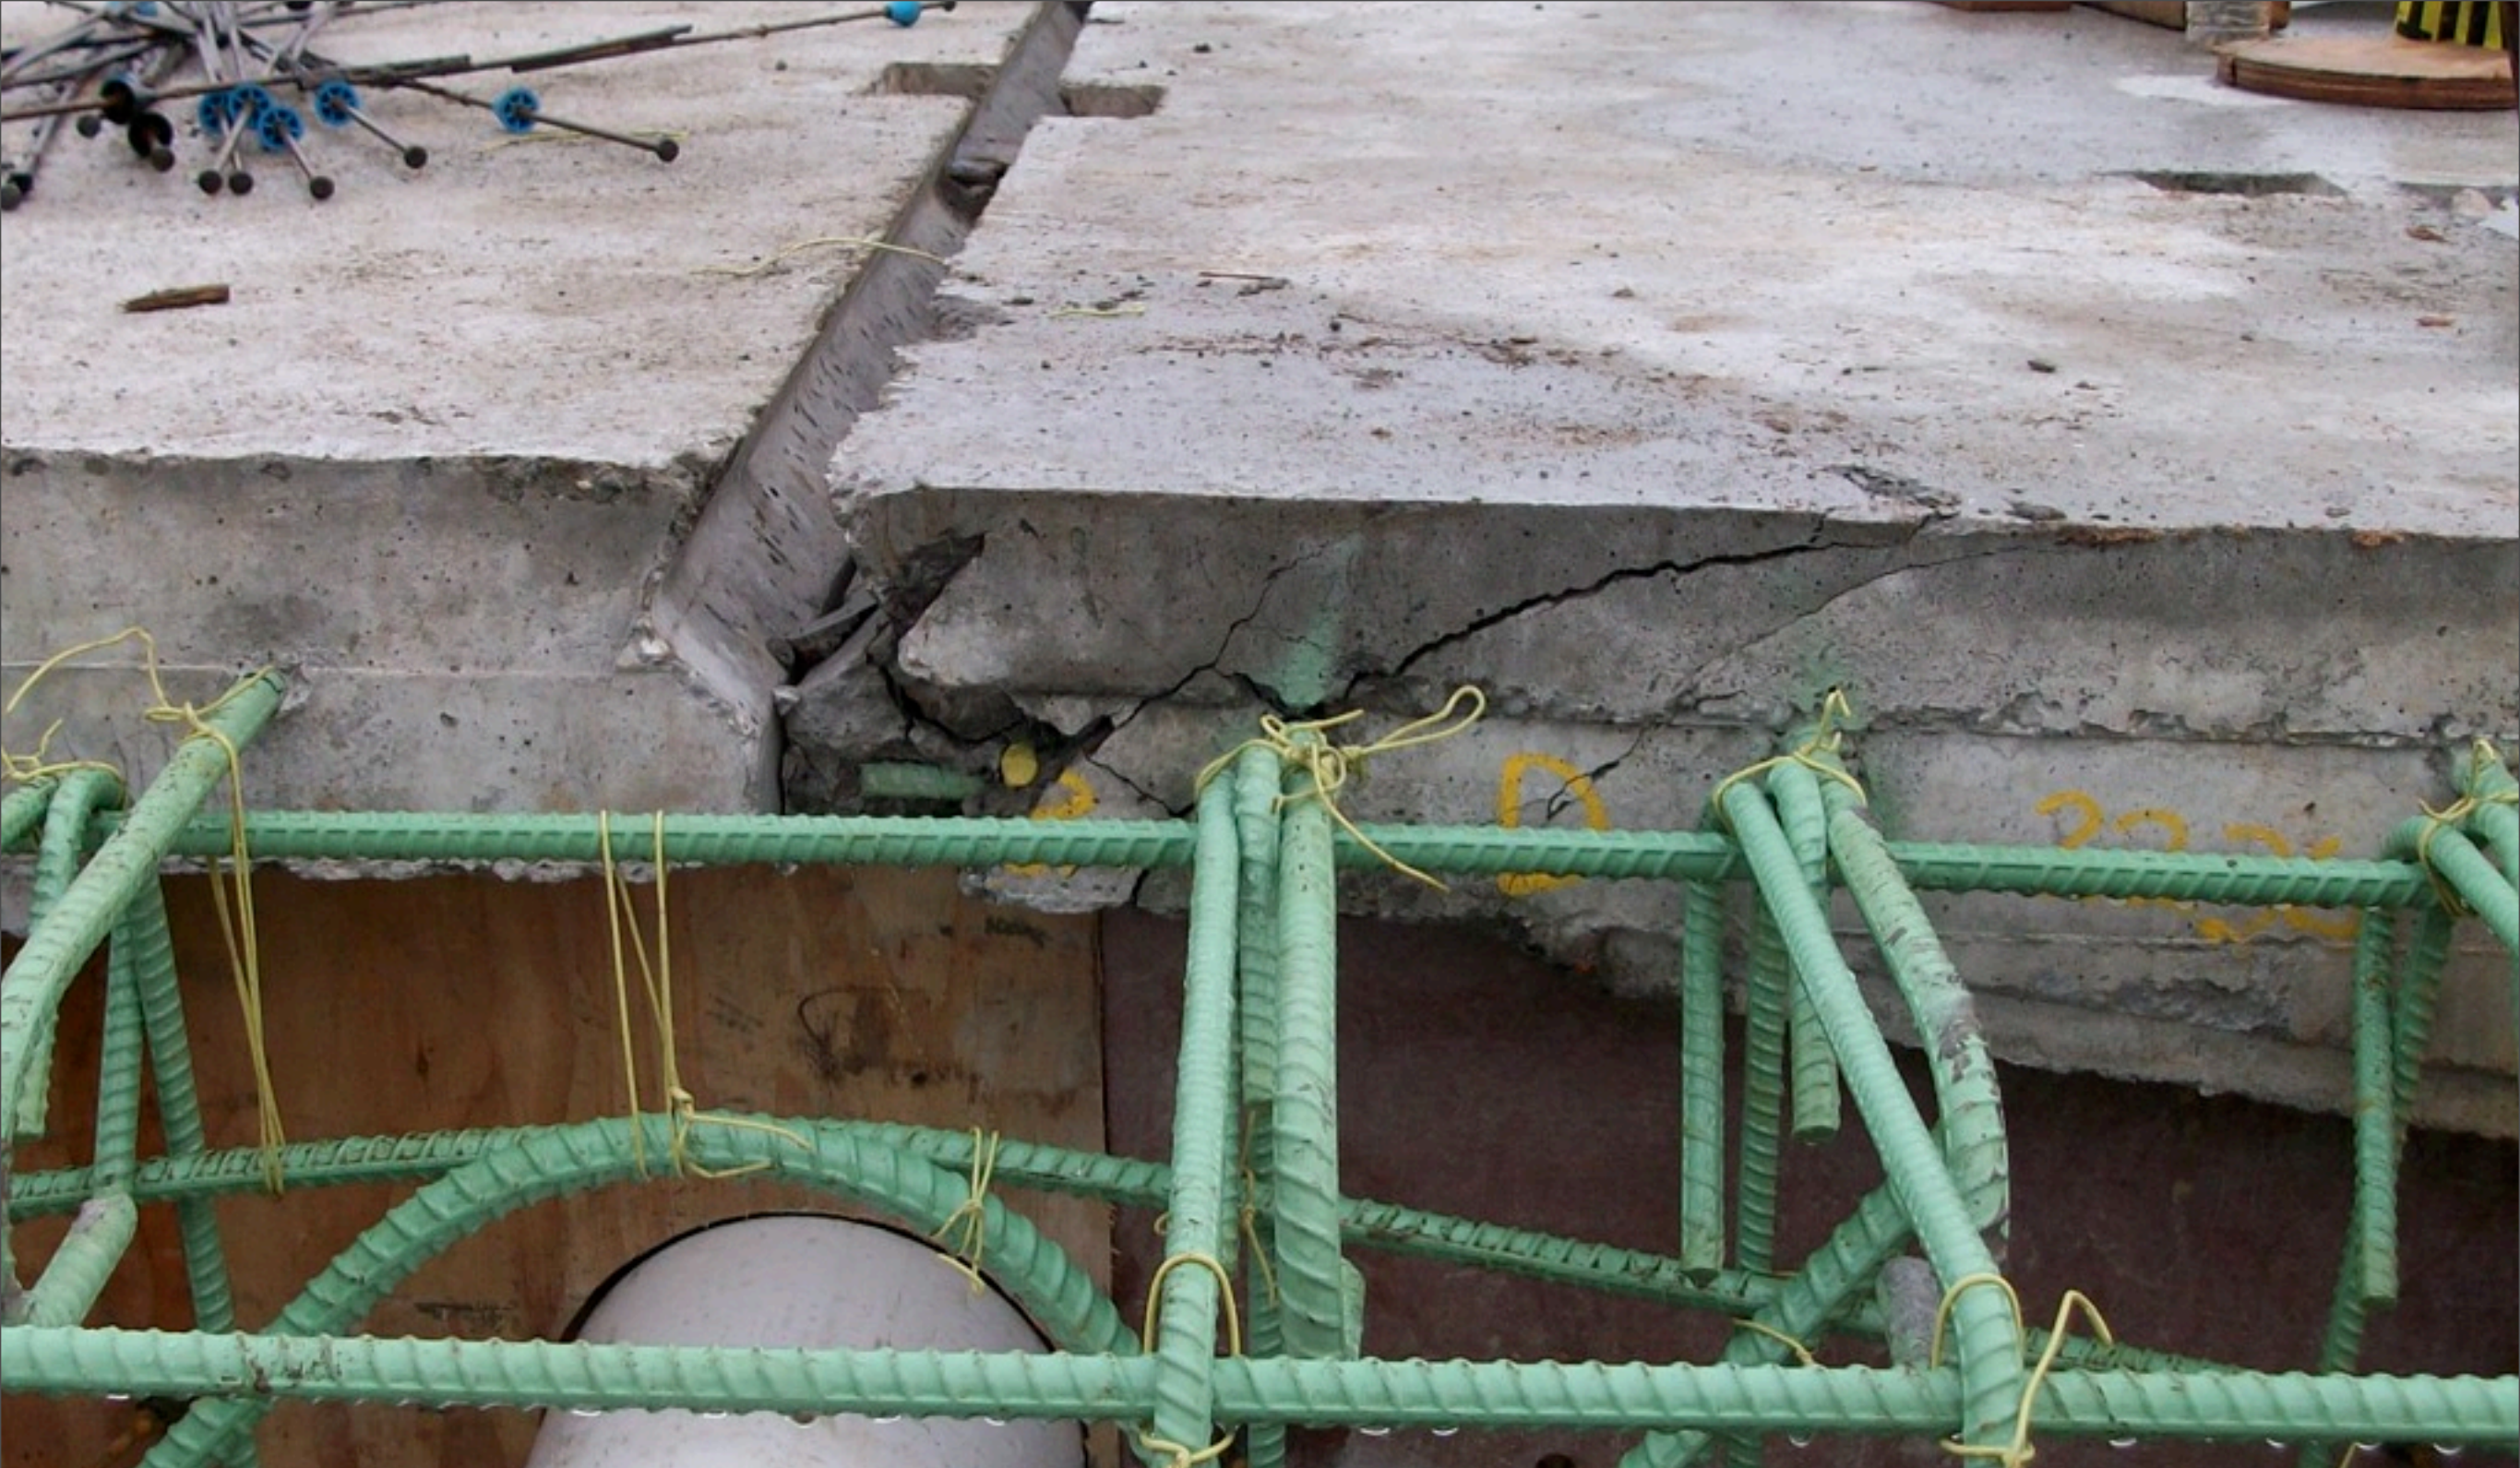
Deck Bulb-T Damaged

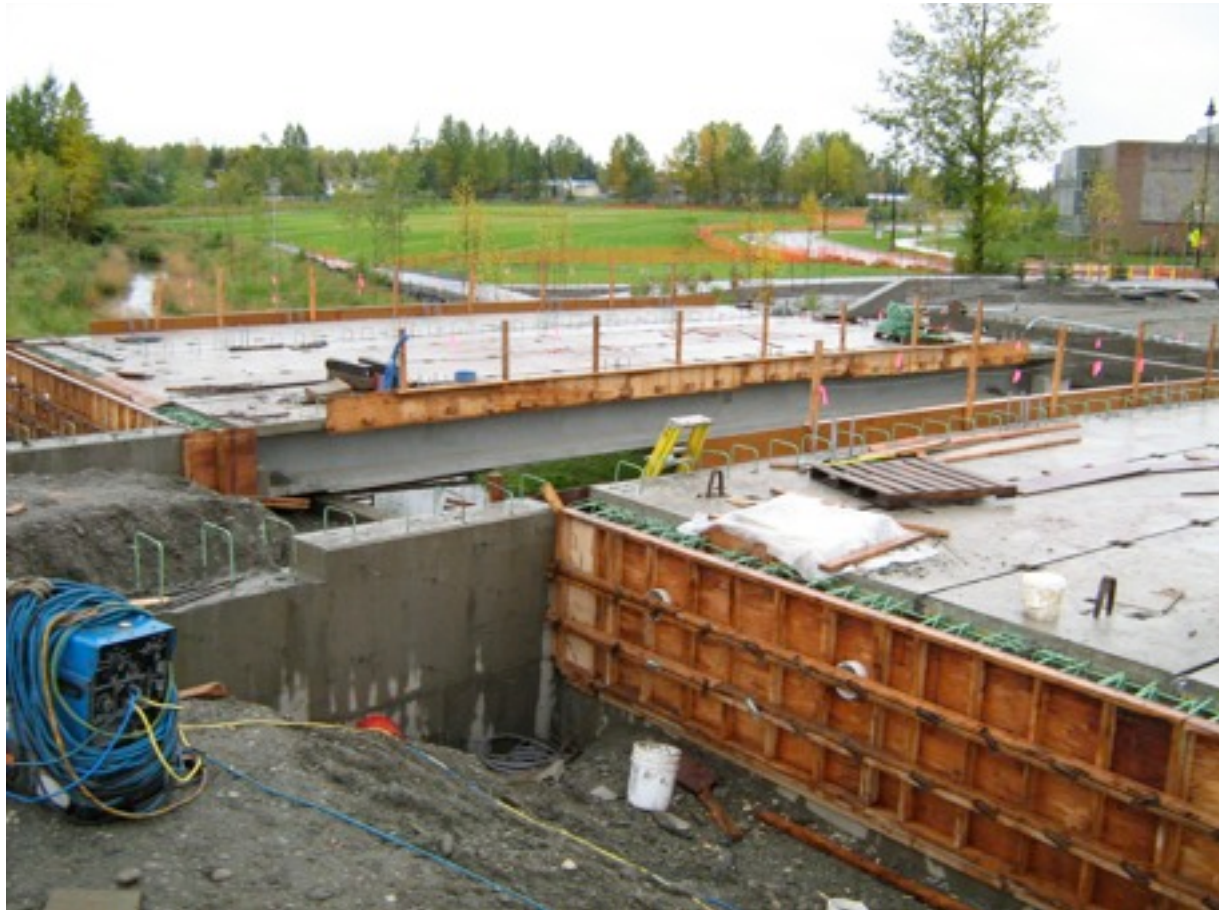
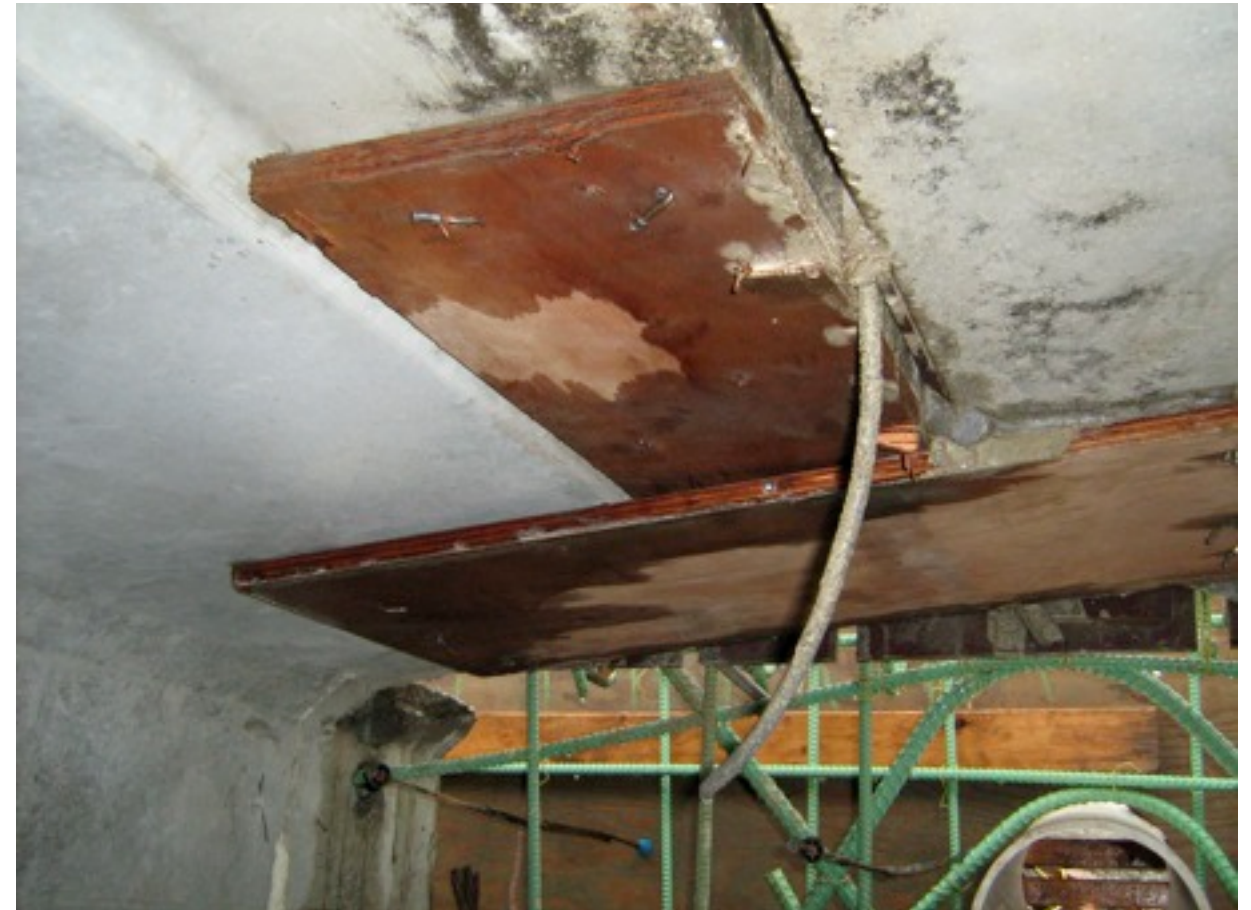
Decked Bulb-T Girder Repair
September 16, 2008

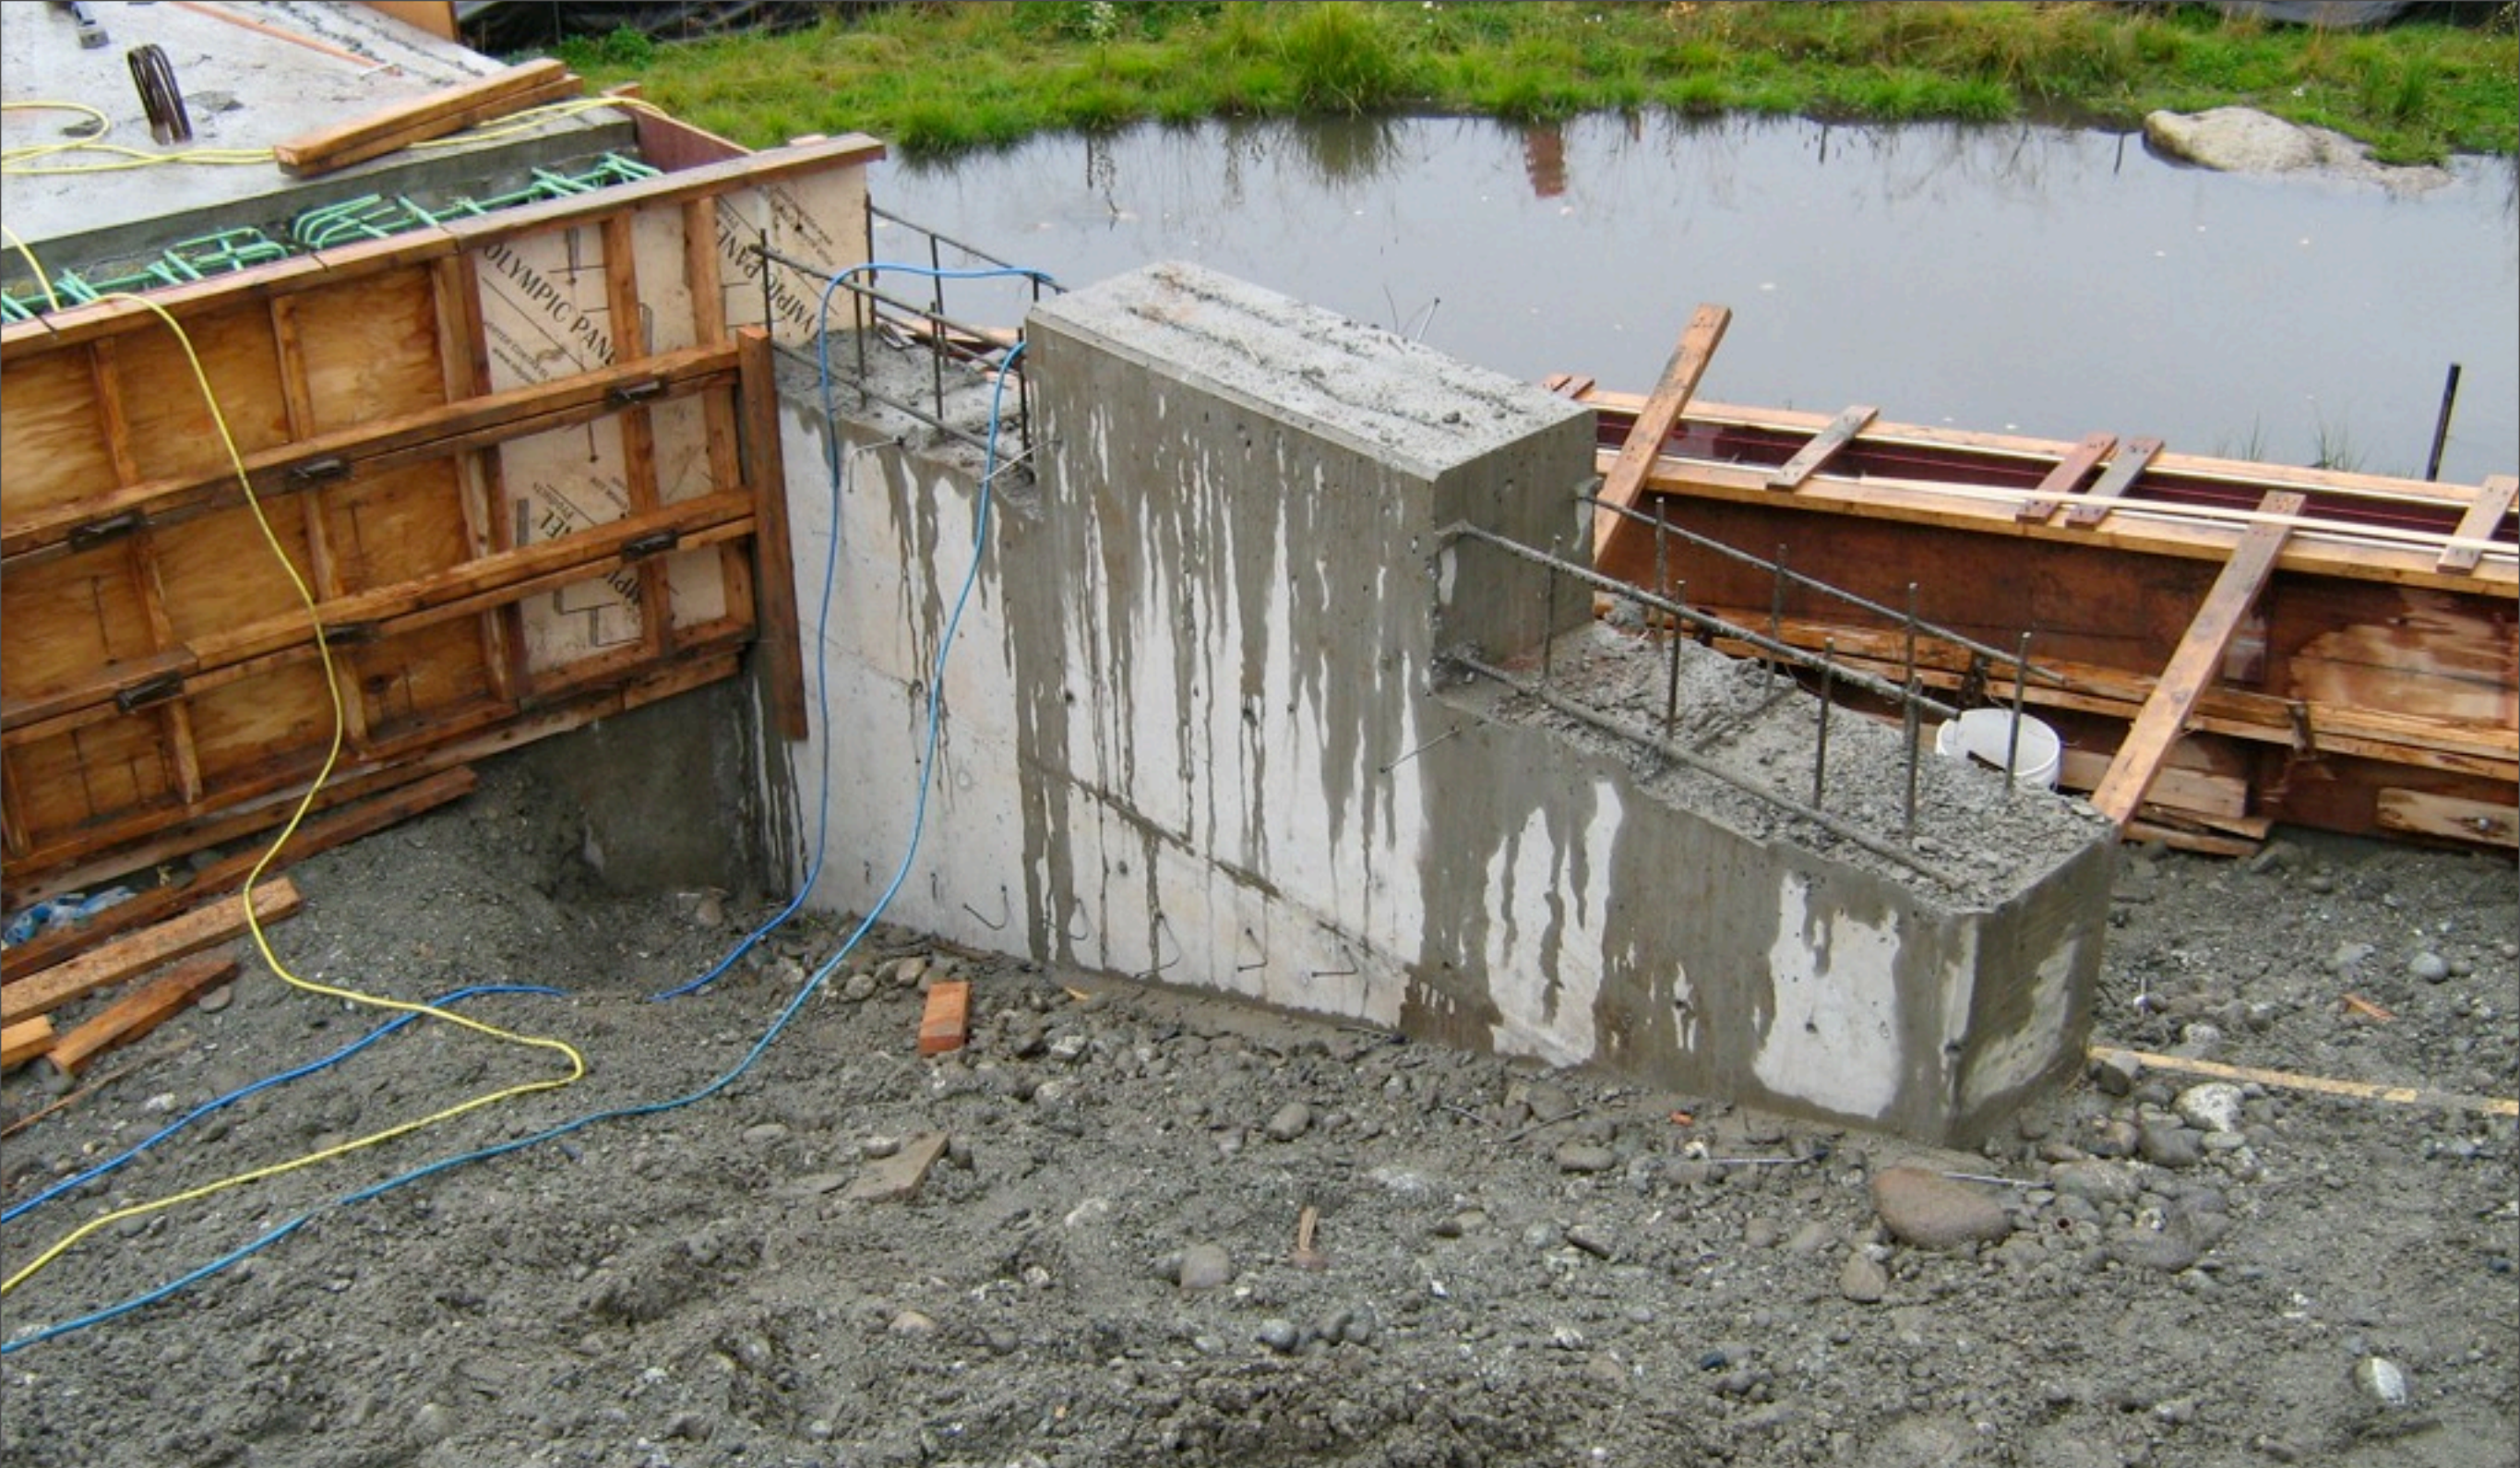
Blockouts for Railing Anchors
